RESTRICTED
SECURITY INFORMATION
AIRCRAFT ACCIDENT REPORT

1. DATE OF ACCIDENT	09100	2. ACTIVITY SUBMITTING REPORT	3. AIR FORCE ACT.
18 DEC 1952	Fighter Squadron 831	7-52	
4. MODEL A/C: F9F-5	5. REPORTING ACTIVITY OF A/C: Fighter Squadron 831		
6. NAME OF UNIT OPERATING THIS AC:	NAS, Moffett Field	7. OPERATIONAL STATUS OF A/C:	2. COMPAIRALAMEDA
Fighter Squadron 831	1. COMCARIRGRU 15	3. COMAIRPAC	
8. LOCATION OF ACCIDENT:	Five miles NW LIVERMORE, California	9. UNIT TO WHICH OPERATOR ATTACHED:	Fighter Squadron 831
10. PERSONNEL INVOLVED (including name and rating code of those served, but deceased or sick)			
A. FULL NAME, RANK, SERVICE, FILE NO. (List portion in lateral first)		B. GUNN	C. POSITION
DANIELSON, Darrell Frederick Allen, Jr. Lieutenant, (b) 1315, USNR		29	EJECTION Seat

29. The Accident

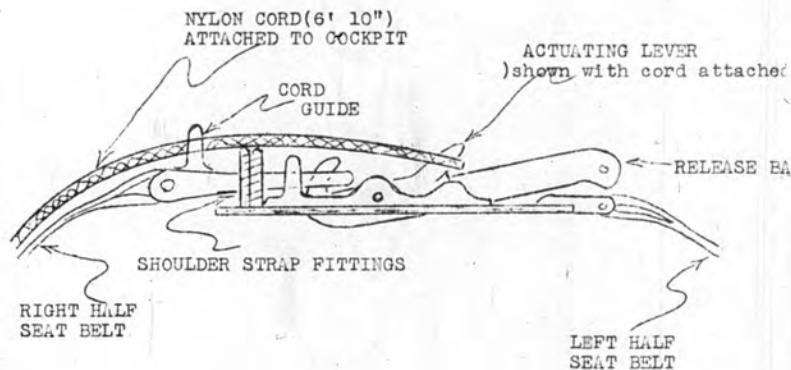
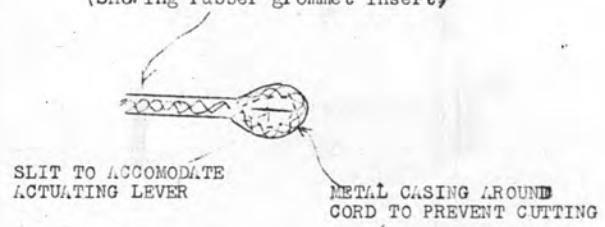
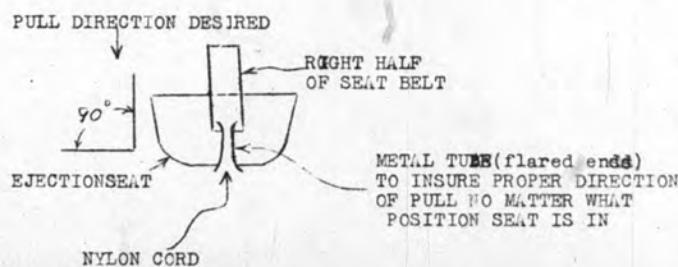
Enclosure (5)

DIAGRAM OF MECHANISM TO AUTOMATICALLY RELEASE PILOT'S SEAT BELT
AFTER EJECTION.

TOP VIEW OF CORD BOOP
(Showing rubber grommet insert)

1. Navy type two-piece helmet, or Air Force P-1 type helmet be mandatory for pilots of jet aircraft.
2. A device be designed and installed to automatically release the safety belt immediately after ejection. A sketch of such a device is attached as Encl. 5.
3. Parachutes be designed to withstand opening at high speeds, and, if possible, be designed to open automatically at low altitudes.
4. The "ejection capsule" be incorporated in new construction aircraft at the earliest possible date.

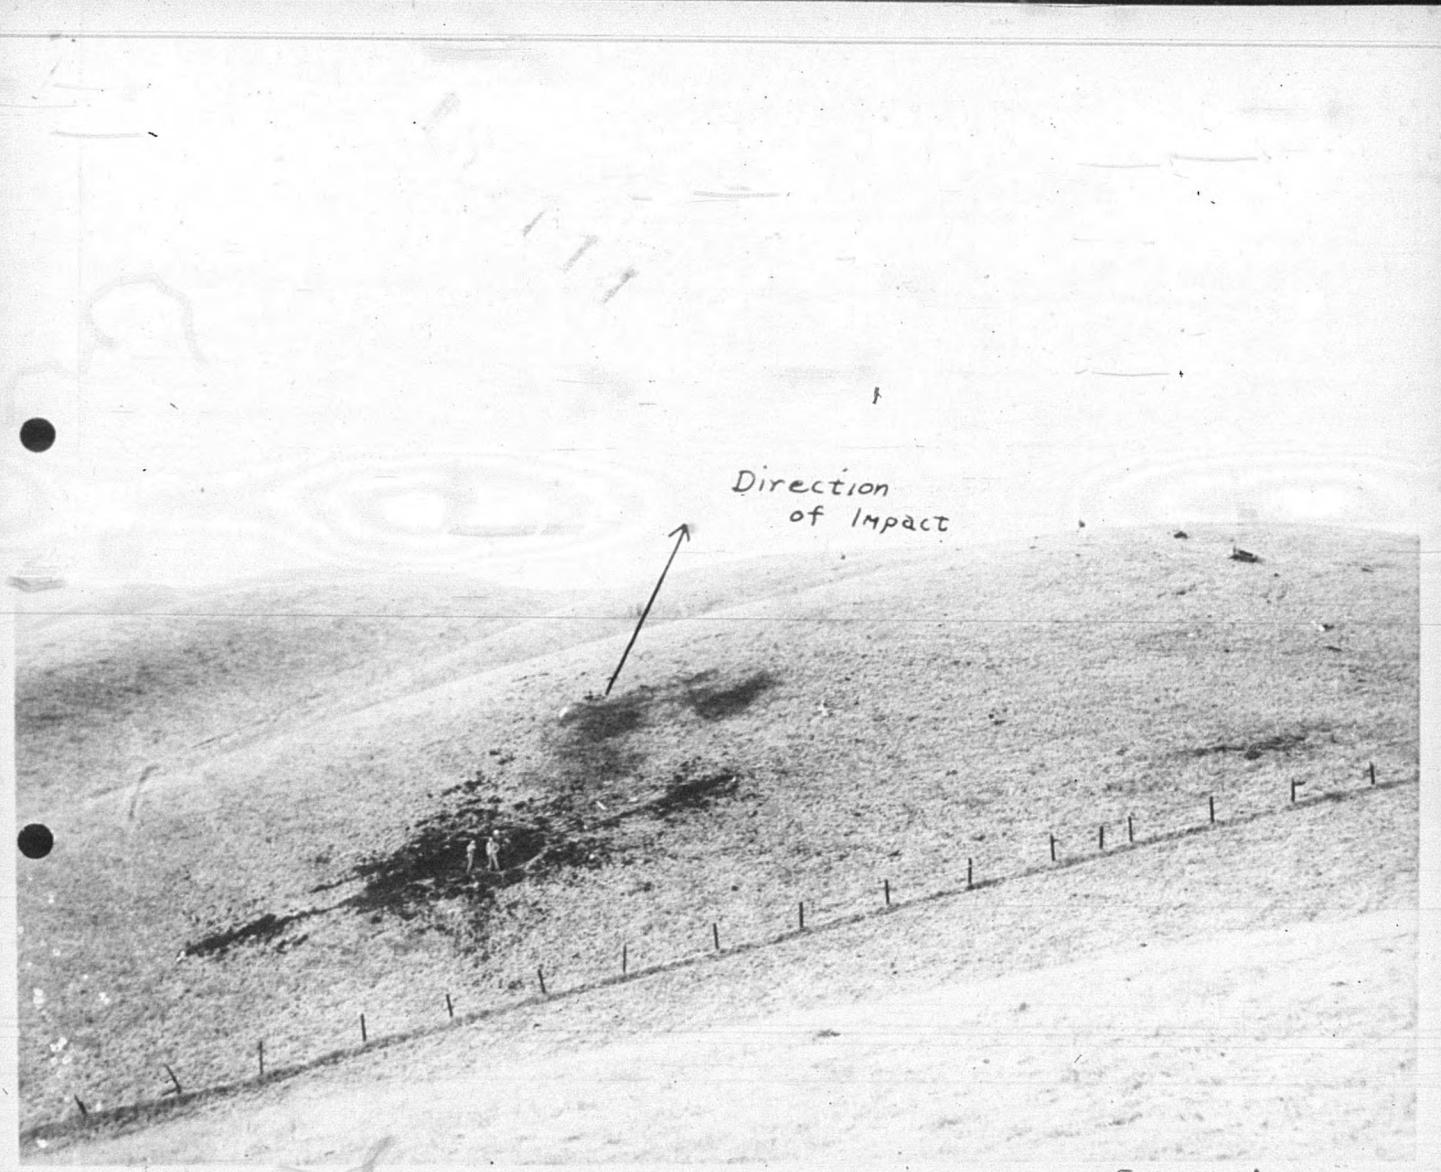
Enc 2 A

Direction
of Impact
